CL:AIRE's NanoRem bulletins describe practical aspects of research which have direct application to the characterisation, monitoring or remediation of contaminated soil or groundwater using nanoparticles. This bulletin describes a remediation pilot study using Carbo-Iron® nanoparticles to treat groundwater contaminated with chlorinated hydrocarbons.

NanoRem Pilot Site — Balassagyarmat, Hungary: In Situ Groundwater Remediation Using Carbo-Iron® Nanoparticles

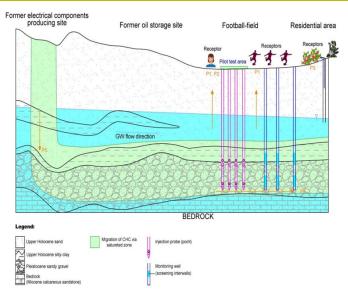
Figure 3. Conceptual site model.

A Conceptual Site Model (CSM) was devised (Figure 3) which outlines the risks associated with the subsurface contamination transport of CHCs towards different receptors in the pilot site test area. Within the CSM contaminant sources released into subsurface during former industrial usages, pathways and associated risks (migration in aquifer, ingestion of local vegetables and fruit irrigated by contaminated groundwater, inhalation of indoor and outdoor air) were identified and receptors (uncontaminated groundwater, water (irrigation) wells, residents, workers and users of soccer pitch, market workers and users) outlined. However, the usage of the groundwater was prohibited by the Local Municipality in the surrounding properties.

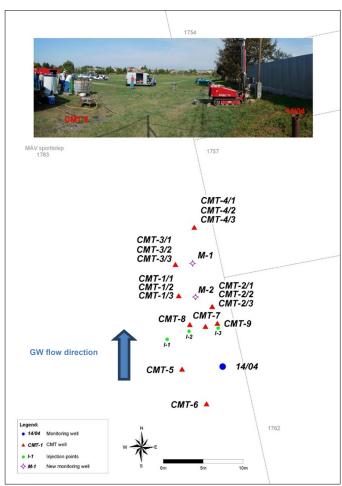
Figure 6. Location of injection points, monitoring wells and data loggers at the pilot site.

Based on the results gained until January 2016 Golder decided to install an additional three monitoring wells (CMT7, CMT8, CMT9) very close to the injection points to get more information about the migration of Carbo-Iron[®]. The layout of monitoring wells and injection points is shown in Figure 6. Monitoring well parameters are summarised in Table 3.

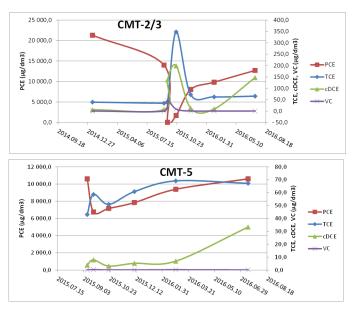
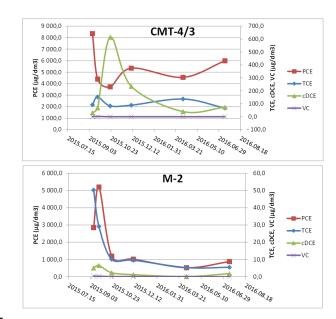
Figure 8. CHCs concentration in four monitoring wells. Injection date was 15/09/2015.

Figure 8 shows the concentration of CHCs in four monitoring wells (three downgradient of injection points CMT-2, CMT-4 and M-2, and one upgradient CMT-5). The decrease in concentration of CHCs were detected after the injection downgradient, along the migration pathway. The most significant effect of the above mentioned degradation was detected in the lowest screened section of monitoring well CMT-2(CMT-2/3). A significant reduction of PCE and enhanced microbiological degradation/chemical reduction in the monitoring wells closest to the injection points was detected but ethene and ethane concentrations, as indicators for CHC abiotic reduction were only detected in low concentrations right after the injection (22/09/2015, 21/10/2015, data not shown). In addition, a small increase of TCE, cDCE and VC concentration was detected compared to the change detected in PCE concentration (Figure 8).

A rebound effect was detected in the closest well to the injection (CMT-2) and also in the CMT-4 well, but the concentration of the contaminants was well below the concentration detected before the injection. The presence of cDCE could be either attributed to intermediate formation in the abiotic degradation pathway or indicates microbial activity beyond the sphere of action in the periphery area represented by CMT-4. The effect of the injection was also detected in the upgradient monitoring well CMT-5 but the results of the long term monitoring might be determined mostly by the natural fluctuation of the contamination and the geochemical parameters of the groundwater upgradient. CMT-5 is located upgradient, between the source (the former plant, Kőporc) and the pilot site.

Figure 8 displays a significant decrease in the PCE concentration in monitoring well M-2, located only 4 m from the closest injection point and no TCE, cDCE products nor rebound effect was detected. The PCE concentration stabilised around 1 mg/L.

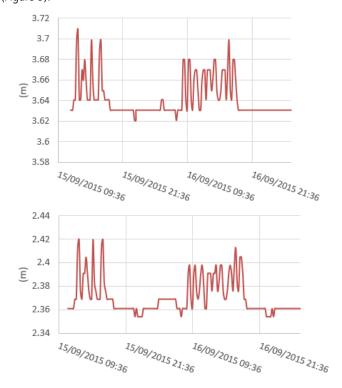
Figure 9. Groundwater level at 14/04 (top) and M-1 (bottom) monitoring wells during the injection (15/09/2016-16/09/2016).

No significant daughter products (TCE, cDCE) were detected in the well CMT-5 (compared to the concentration of the primary contaminant (PCE)); the immediate decrease of the concentrations after the injection can be attributed to dilution due to the injected volume. All the 13 injection events that were carried out in 2 days (September 2015) were registered by the data loggers installed both in M-1 (downgradient) and 14/04 (upgradient) monitoring wells (Figure 9).
